# White River Bank Restoration and Monitoring Project ANRC Project No. 13-1100

Matt Van Eps, Watershed Conservation Resource Center  
ANRC 2016 NPS Program Annual Meeting  
September 27 and 28, 2017

# Project Goal

Reduce streambank erosion and associated sedimentation along a minimum of 1,250 feet of riverbank on the White River

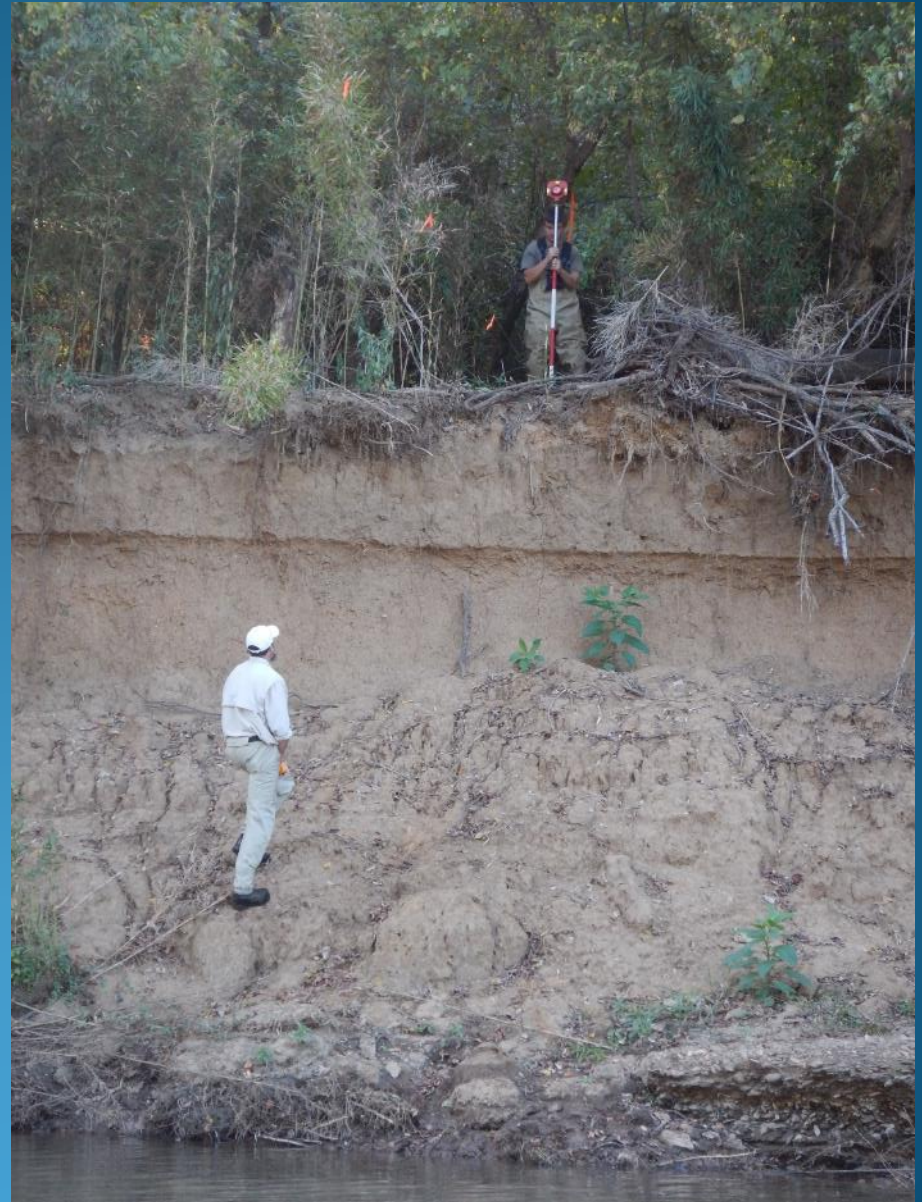
- White River
- 400 mi<sup>2</sup> drainage area
- 18' tall banks
- 12,000 cfs  $Q_{bkf}$
- 180'  $W_{bkf}$

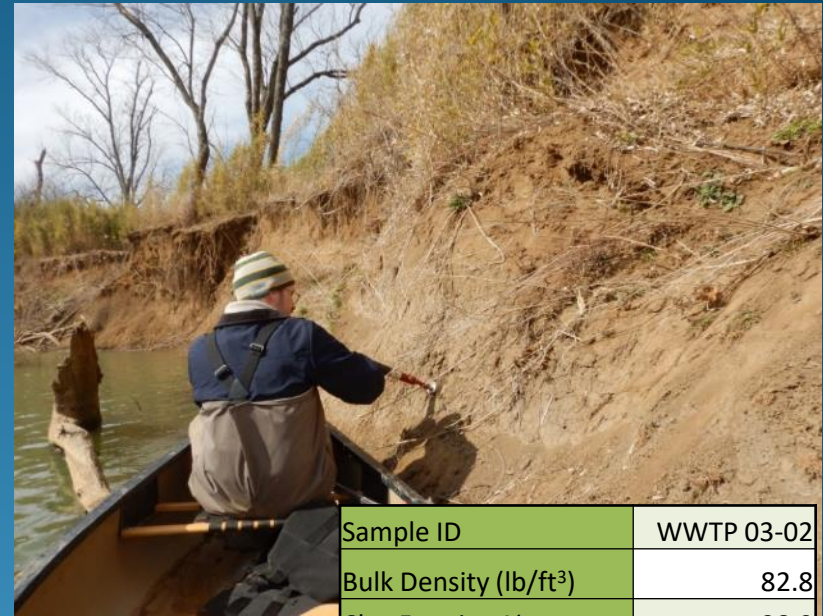
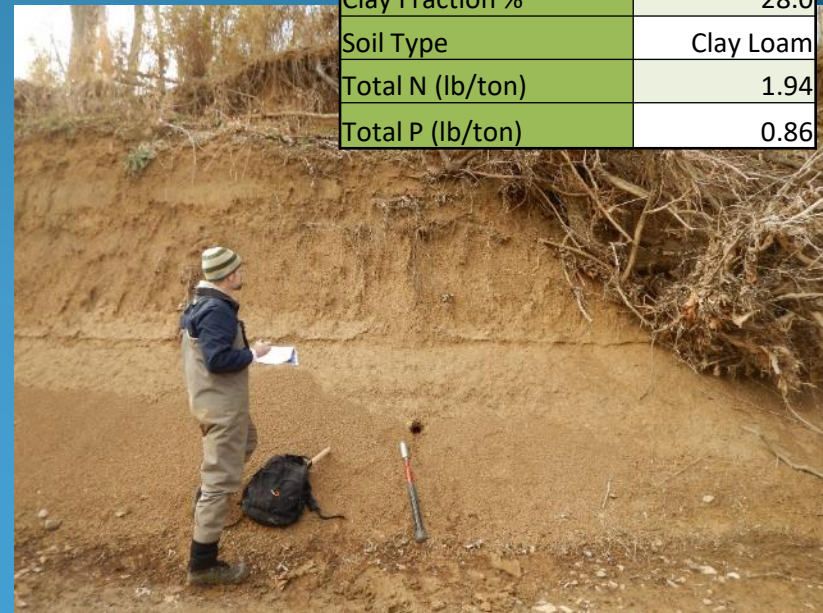
- Streambank Soil Samples Collected
  - 17 samples collected

Sample ID	WWTP 03-02
Bulk Density (lb/ft <sup>3</sup> )	82.8
Clay Fraction %	28.0
Soil Type	Clay Loam
Total N (lb/ton)	1.94
Total P (lb/ton)	0.86

Parameter	Min	Max
Bulk Density (lb/ft <sup>3</sup> )	74.9	93.1
T. Phosphorus (lb/ton of sediment)	0.55	1.2
T. Nitrogen (lb/ton of sediment)	1.5	3.3

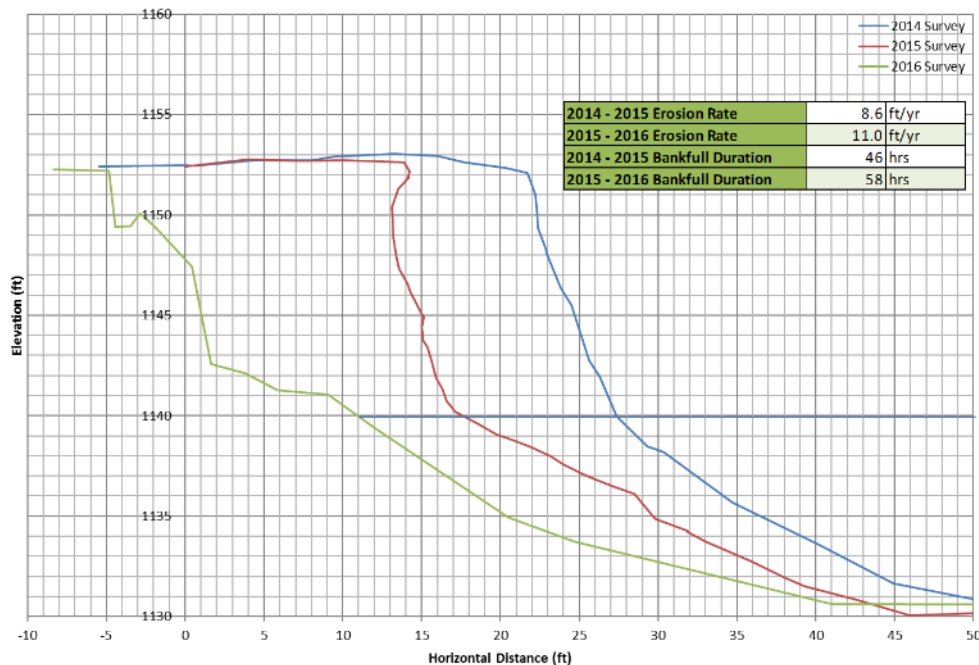
White River Bank Stabilization - XS4

- Streambank Profiles Collected
  - Seven Sites Evaluated
  - Bank Profiles Surveyed 3 times
    - 2014, 2015, 2016
  - Erosion Rates Determined
  - Potential Load Reduction Estimated

Erosion Rate (ft/yr)	2014-2015	2015-2016
xs1	5.3	3.8
xs2	1.6	7.2
xs3	1.0	10.8
xs4	8.6	11
xs5	12.7	5.3

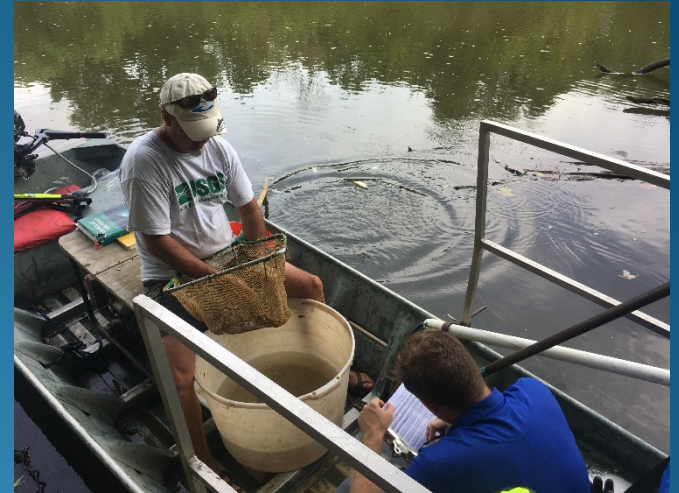
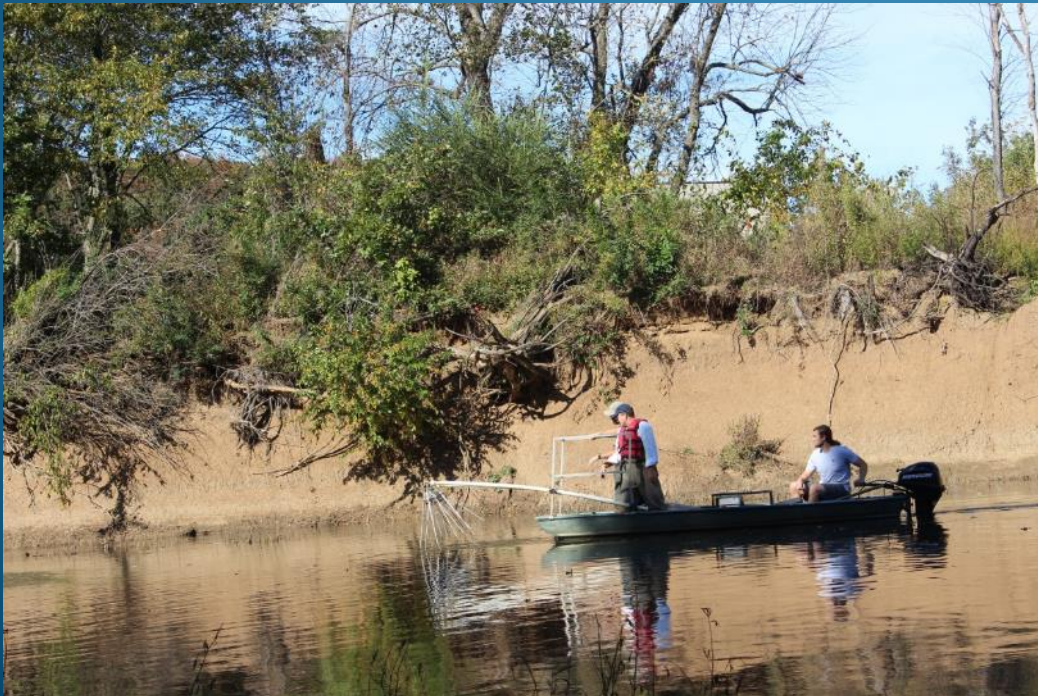
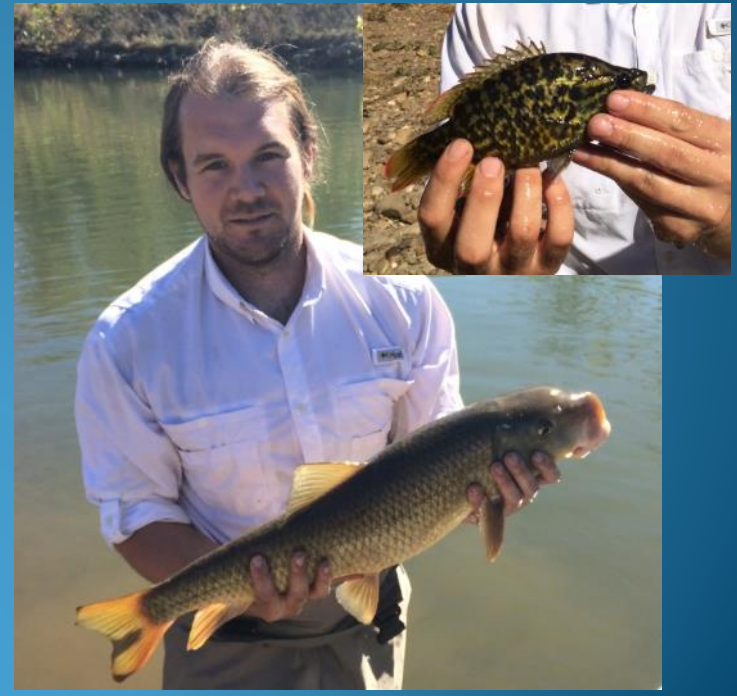
- Initial Fish Sampling Conducted
- October 2014
- Fish numbers and species varied by habitat type
- Resampled July 2017
- Data is being evaluated

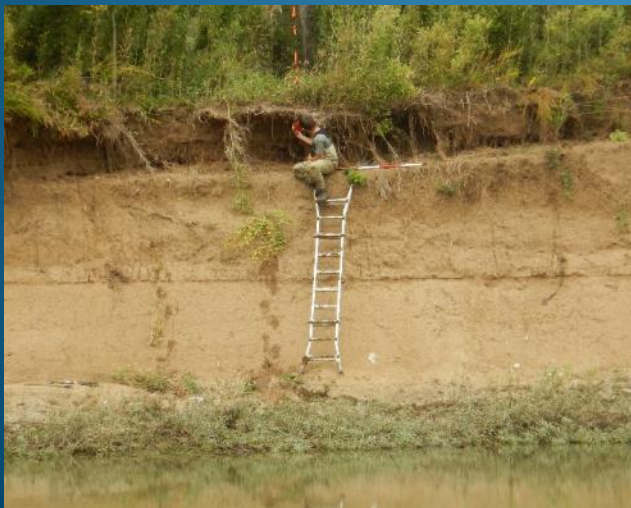
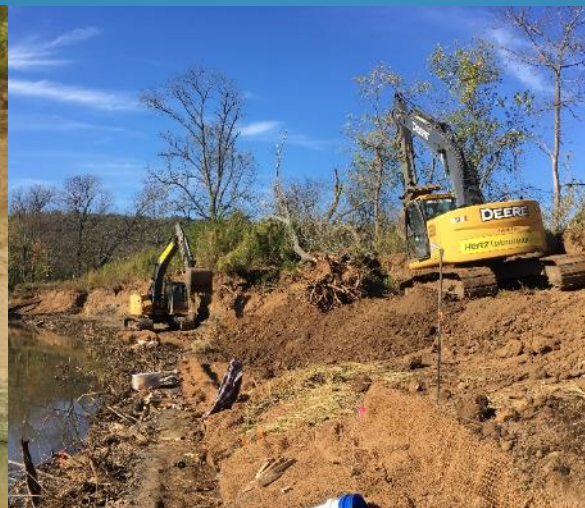
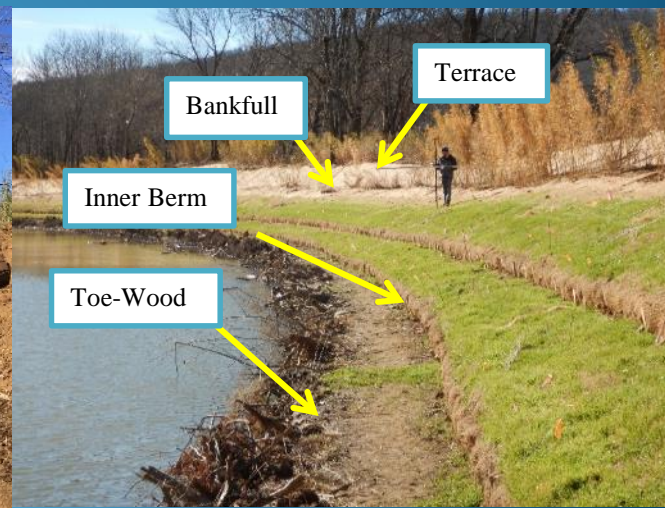
- Site Geomorphology Data Collected
- Topographical and Other Survey Data Collected
- Restoration Design Complete
- Permits Were Received
- Construction Bids Received

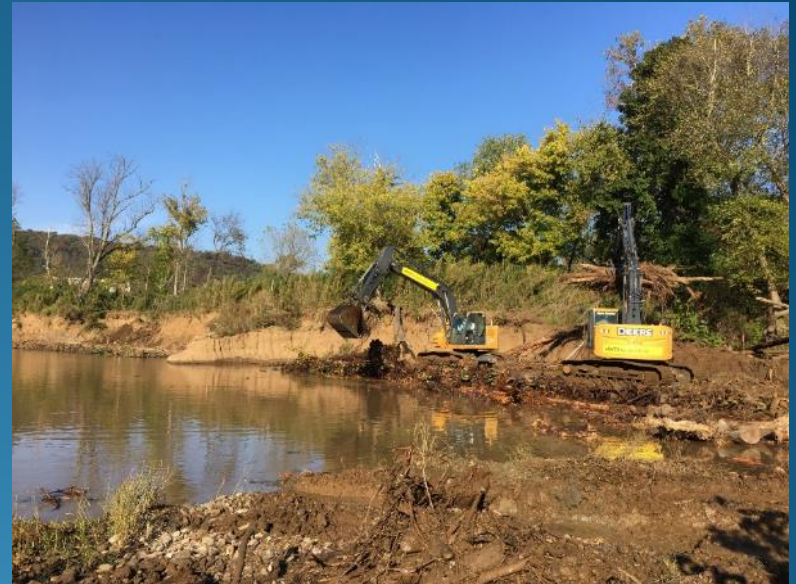
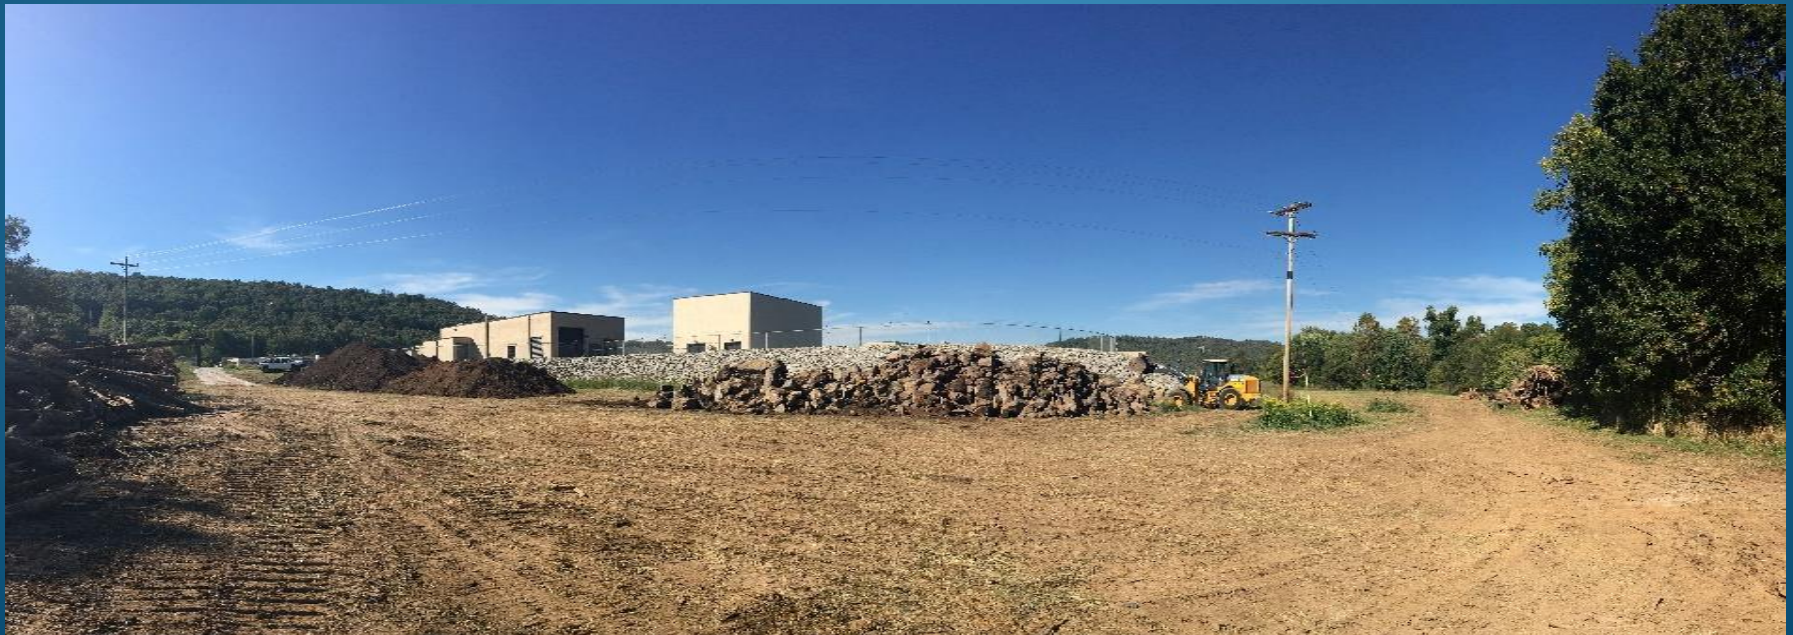
- 600 Trees (reclaimed)
- 4,000 yd<sup>3</sup> of Fill Earth
- 1,000 yd<sup>3</sup> of Rock
- Construction Began October 14, 2016
- Heavy Construction Completed December 12, 2016
- 4,500 Tree and Shrub Seedlings
- 1,000 Grass Plugs
- Planting continued through March 2017

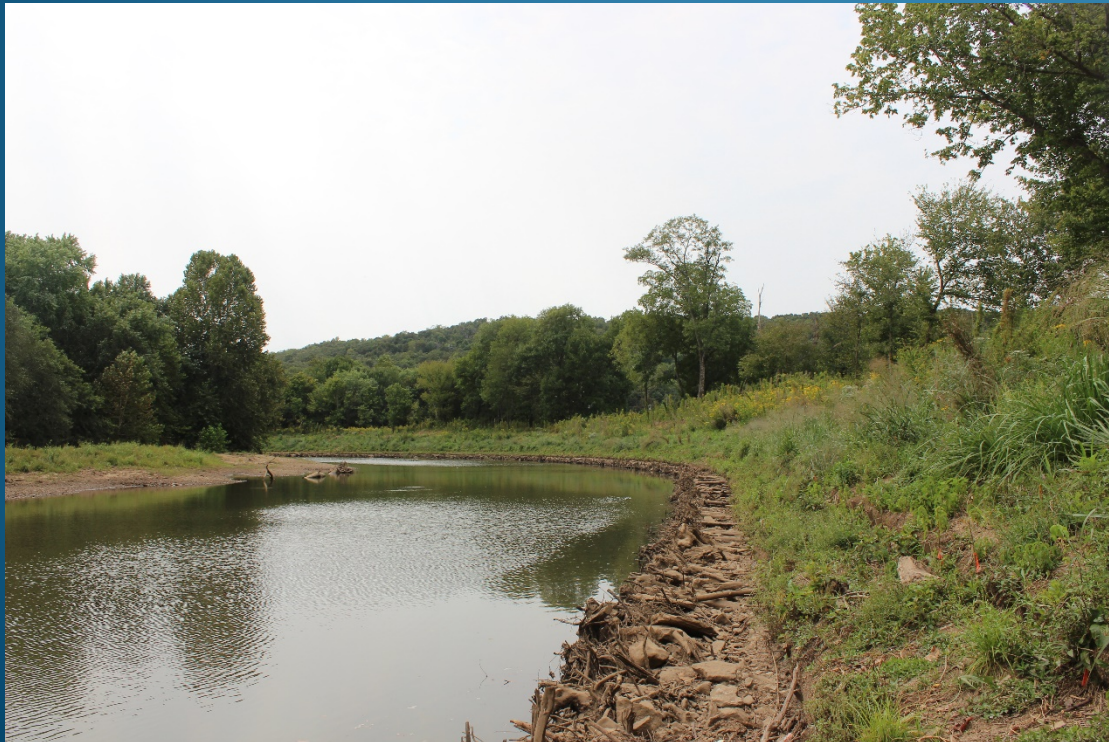
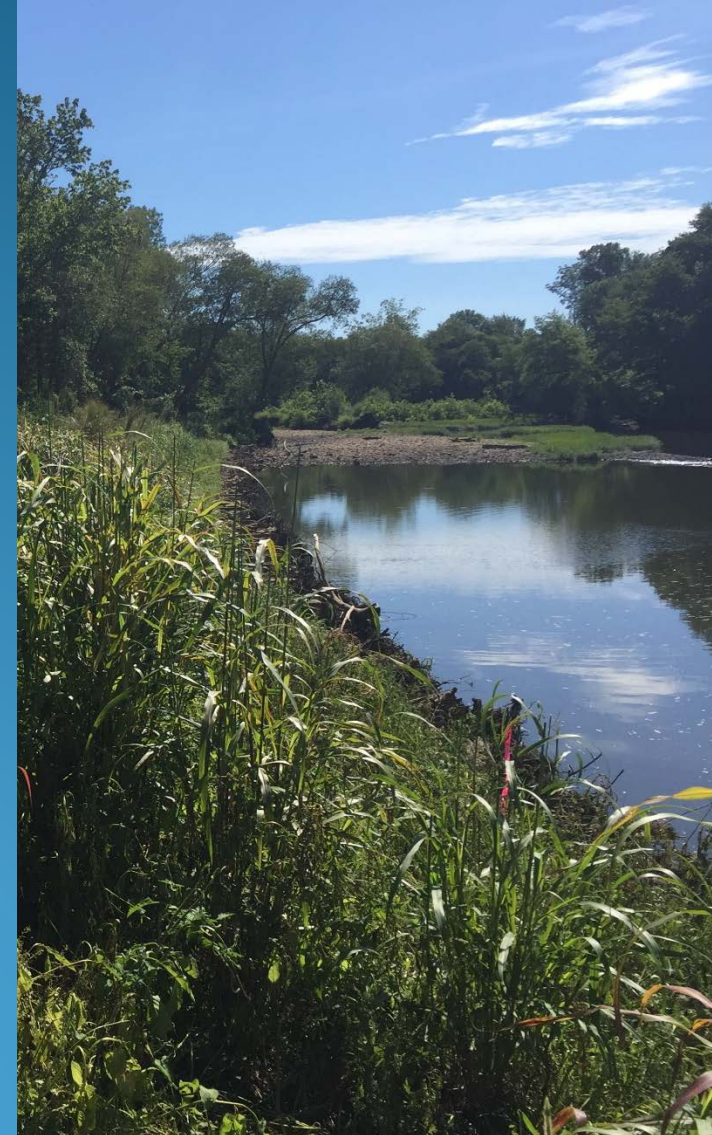
- Over 1,200 Feet of Riverbank Restored
- Reduced Annual Sediment Loads by 3,600 ton
- Reduced Annual TP Loads by 3,200 lb
- Improved Aquatic Habitat
- Established Native Riparian Area
- Protected Civil Infrastructure
