Filamentous Algae Control Demo on Spring Fed Pond

Oliphant Pond Project

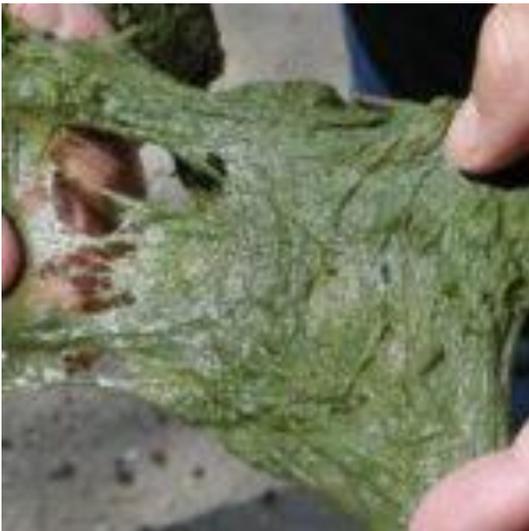
Filamentous algae can be picked up by the handful off the surface of a water body. Sometimes a large enough mass can be picked up that it could be compared in volume and weight to a wet towel.

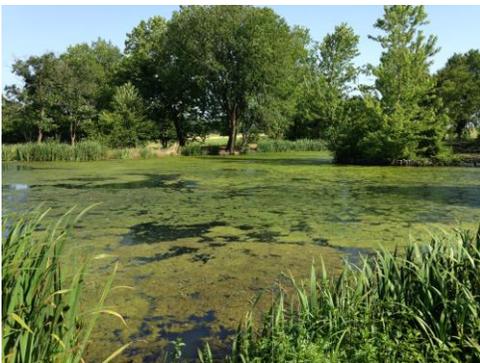
At the start of summer 2019, the pond was nearly totally covered with filamentous algae.

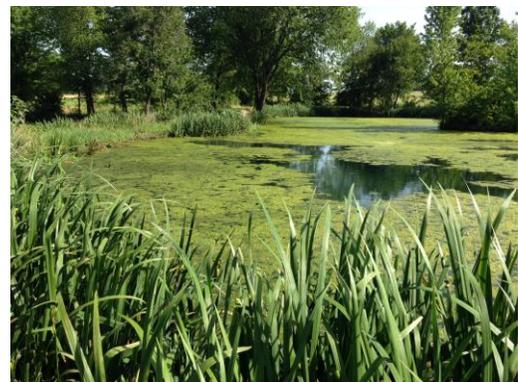
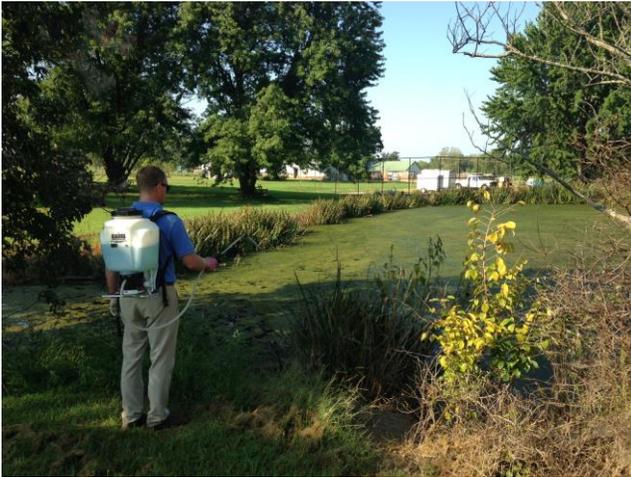
Cutrine Plus was applied using a 3 gallon backpack sprayer from the shore.

Citrine Plus was mixed at a rate of 1 gallon of Citrine Plus with 2 gallons of water in a battery powered backpack sprayer. Spray was applied by walking around the edge of the pond and spraying as far as possible out into the pond. In the shallow area of the pond, waders were used so applications would reach out farther from the shore.

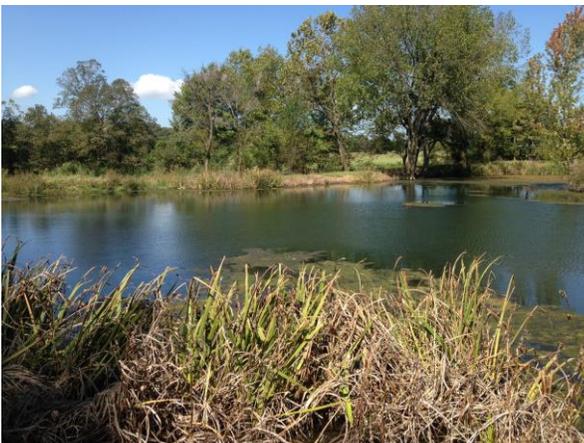
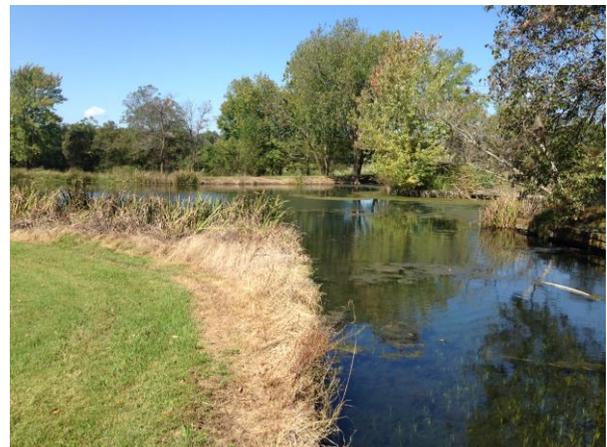
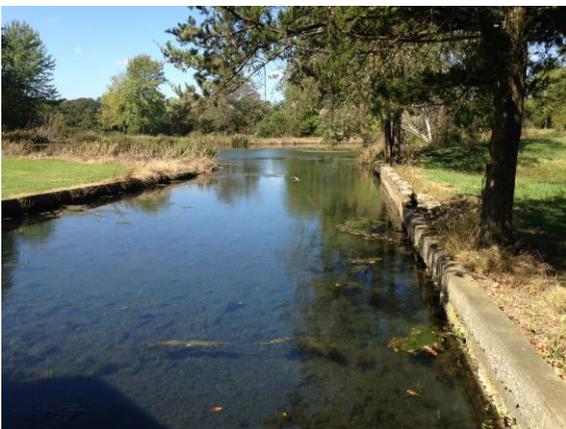
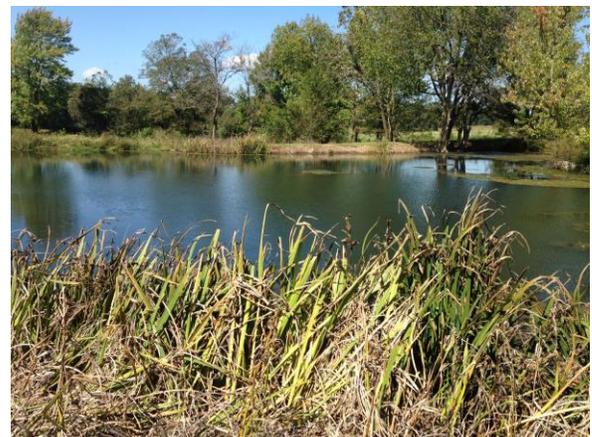
After Treatment:

Although not 100% control after one treatment, it was estimated at over 75%. All label directions should be followed to prevent unintended consequences. Excessive plant die off can result in an oxygen shortage in the body of water which can result in a fish kill.

A boat or sprayer which would reach farther out into the water body would most likely improve results also.

Additional treatments would likely be required through the summer to maintain the look of the pond. Fewer subsequent treatments would be required in a pond that had less continuous water flow into the body.
